Local Development Framework
Evidence Base

Shopland Churchyard
Conservation Area Appraisal

This document was produced by Essex County Council for Rochford District Council in July 2006.

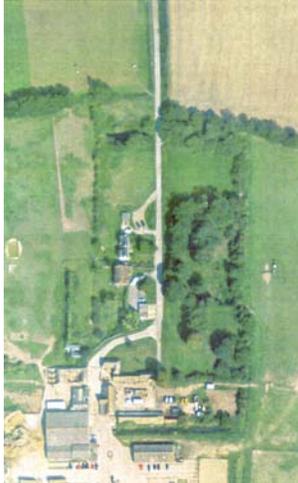
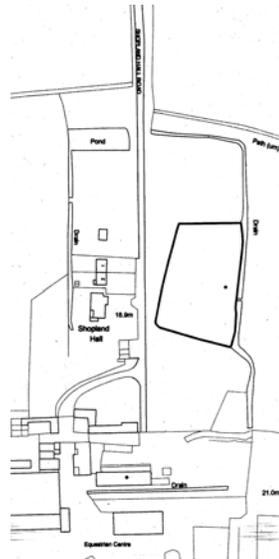
*Figures 2 and 3.
Location and setting of
Shopland Churchyard*

2.1 The Shopland Churchyard Conservation Area is located approximately three miles north east of Southend-on-Sea and one mile south east of Rochford. It is positioned on the east side of Shopland Hall Road, a short private road running south off Shopland Road in the parish of Sutton, which incorporates the former parish of Shopland. The River Roach lies to the north.

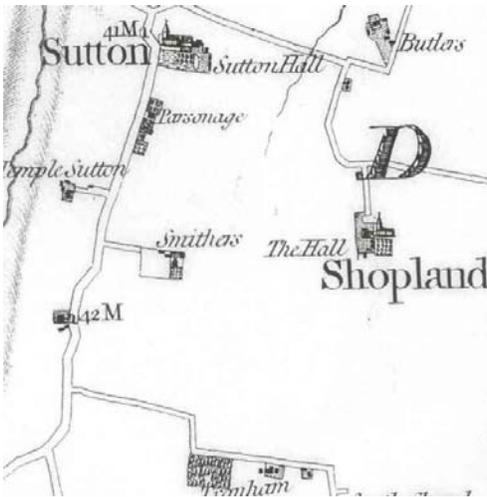
Figure 5.
Chapman and
Andre Map,
1777

- 3.2 Medieval occupation was focussed on Shopland Hall, located on the west side of the lane leading up to the church from the Shopland to Barling road. The Chapman and Andre map of 1777 (*Figure 5*) shows the church and hall at Shopland. It illustrates the dispersed nature of the settlement in the area with church/hall complexes and scattered farmsteads.

- 3.8 The Chapman and Andre map of 1777 and the Tithe Map of 1839 show Shopland Church as part of a small complex with Shopland Hall in a rural setting not linked to a village settlement. This pattern of dispersed settlement is typical in this part of Essex.
- 3.9 The First Edition OS map shows that trees were significant both in the hedge line of the enclosure and within the open space at that time.
- 3.10 Subsequent OS Maps show that the isolated nature of the small settlement complex continued.

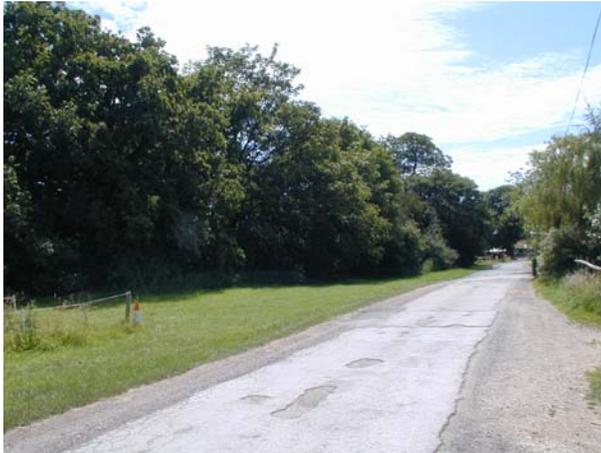
Figure 9. The approach along Shopland Hall Road. The churchyard lies behind the tall hedge on the left

- 4.1 The edge of the Conservation Area is defined by the thick boundary hedge of Shopland Churchyard. The churchyard is fully enclosed by this tall hedge, which provides no inward views on the approach down Shopland Hall Road and there are no clues to its existence. There are views of modern equestrian buildings at the end of the road, and as one reaches modern cottages on the right hand side the churchyard reveals itself through a gap in the hedge line.

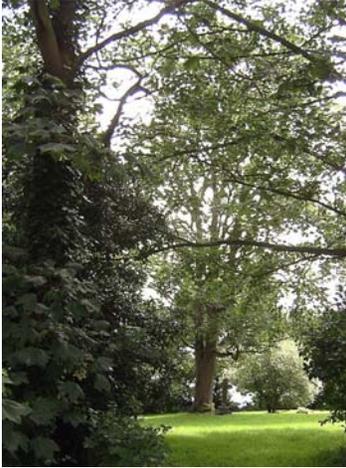
Figure 10. View through the entrance into the churchyard

- 4.2 Through the entrance one first catches sight of a tall monument and a low cross at the foot of a large sycamore tree. On entering the churchyard, the full extent of the site can be taken in, with views across the open green space to small dispersed groups of gravestones, mature trees and scrubby vegetation. Across to the south, shallow grassy earthworks mark the original position of the church. There are no paths or routes through the churchyard, and the visitor can wander freely. From within the space, the rich green boundary provides a sense of complete enclosure and isolation, and, at least in the summer months, affords few glimpses of the agricultural landscape beyond.

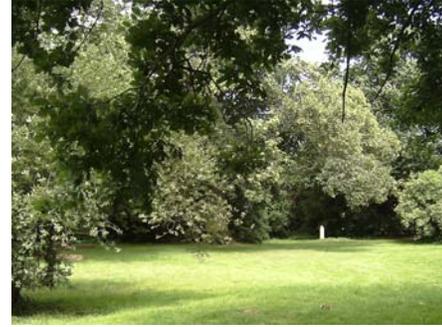
Figure 11. View north from within the churchyard

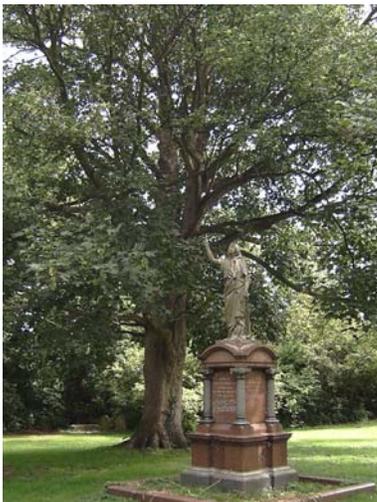
Figure 12. Memorial to the Utton family of Shopland Hall

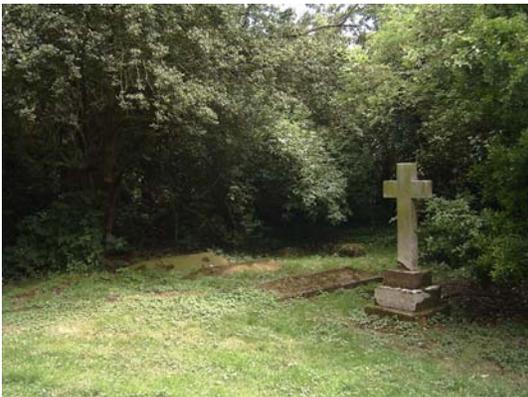
5.4 The remaining gravestones are modest in scale and simple but varied in design, with a generally informal arrangement. In addition to the Utton monument, other gravestones mark the resting place of important local individuals, including the local historian Philip Benton, whose grave is marked by a simple flat memorial alongside those of other family members in the north-east corner, and Frederick Thackeray, cousin of the author William Makepeace Thackeray. Other notable individuals whose remains were interred at Shopland but whose memorials have been removed are the aforementioned Thomas de Stapel, and Charles Tyrell, incumbent, who died in 1695 and whose memorial carried an ancient curse against its removal or desecration. Two adjacent head and foot stones on the south side of the site of the church, dated 1718 and 1727, are Grade II listed. The oldest memorial is on the south side close to the site of the south porch of the church, and is a large flat stone now heavily eroded and illegible, but believed to be that of William Haker, dated 1639. To the south there is an attractive and orderly arrangement of nine Victorian graves with upright headstones, body tombs and footstones. The most recent burials are of the 1930s⁶. The graves are free of flowers, plant holders and other ornamentation.

Figure 13. The Benton family memorials

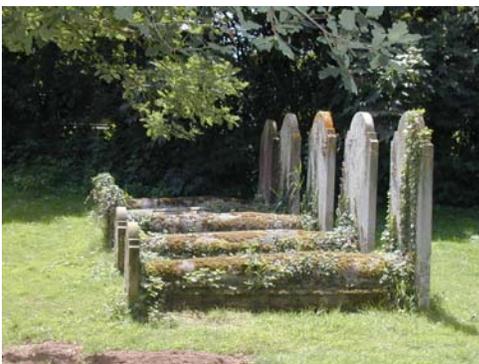
Figure 14. Group of 19th century gravestones

- 5.5 A significant proportion of the gravestones, perhaps a third of them, are overgrown by bushes and weeds, including ivy and self-seeded sycamore, and some have been completely engulfed by scrub encroaching from the boundary hedge. A small number have fallen, or have parts missing, others are badly eroded and have lost their inscriptions.

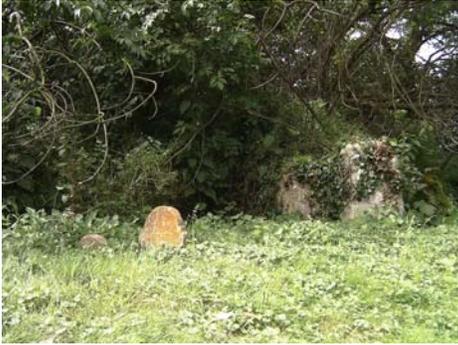
Figure 15. Listed 18th century head and foot stones

- 6.2 A number of notable local individuals are buried at Shopland, and their graves are the focus of local pilgrimages. These should not be surrendered to the encroaching scrub but should remain accessible for visitors. The two listed head and foot stones are also suffering damage from encroaching vegetation.

2 adjacent head and foot stones. 29 December 1718 Peter Lodwick and 1727 Peter Lodwick and his wife Margaret, both with scrolled sides and heads and central foliate scrolls. The footstones inscribed PL 1718 and PL 1727 respectively. Shopland Church was demolished C20.

- 7.1 Low level maintenance of Shopland Churchyard has contributed to its naturalistic character, and whilst continuing this approach will maintain character in the short term, a management plan for the trees and hedge is required to prevent further encroachment and loss, in accordance with

- 7.2 There are three options that would be appropriate for Shopland Churchyard in its rural setting.
- Management to maintain the *status quo*, preventing further encroachment of scrub resulting in continuing loss and damage to the overall form, and to key gravestones and the site of the church.

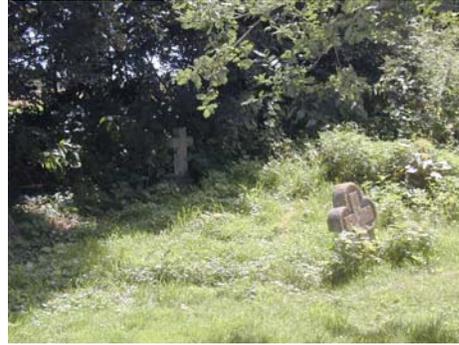
Figure 16. An overgrown group of gravestones in the south-east corner

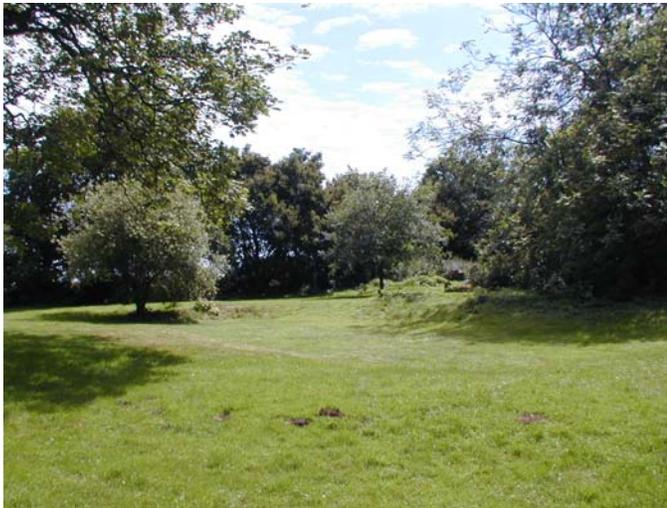
- 5.6 Shallow rectangular earthworks and residual masonry now barely visible beneath grass and vegetation, mark the original position of the church, adding interest and variety to the landscape. Like all parish churches, its site is of great historical and archaeological importance.

Figure 17. Earthworks marking the position of the church

- 6.3 The earthworks and residual masonry of the church are in danger of becoming overcome by grass and vegetation. The site is both historically important and provides visual interest in the landscape and should be preserved.

- 7.6 Although the original position of the church is visible in the shallow earthworks and masonry, this would benefit from clearer, but low key, indicators, perhaps with corner stones to act as markers.

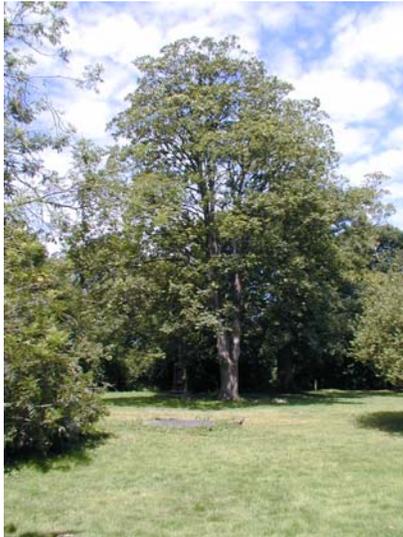
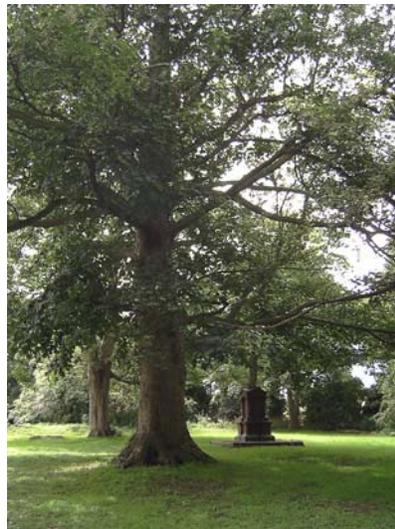
5.7 Shopland Churchyard has significant interest as a green space, with its mature boundary hedge and trees providing wildlife habitat, and attractive greensward. The existing boundary trees and vegetation appear mostly to have grown up by natural regeneration rather than as part of a formal planting scheme, but the First Edition Ordnance Survey map clearly shows that trees were a significant feature of the churchyard in the past. The boundary today is formed mainly of self-propagating species, particularly sycamore. There is one large yew tree in the northern boundary. In some areas, notably at the southern end of the west boundary, the encroaching scrub is altering the shape of the churchyard, and swallowing gravestones around the periphery. Two mature sycamores dominate the northern half of the churchyard, their broad trunks and spreading boughs framing appealing vistas and creating patterns of light and shade on the ground. Elsewhere to the south immature saplings are growing near the church earthworks.

Figures 18 and 19. Mature Sycamore trees make a significant contribution to the character of the churchyard.
